Progress Evaluation Applying Earned Value Management in the Construction of Commercial Buildings

**Presented by
Planning & Management Services, Inc
Federal Way, WA (near Seattle)**

Case Study

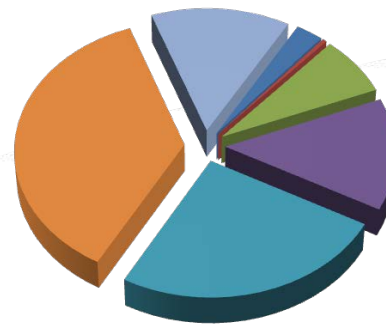
- Analyze Schedule and Coding Structure
 - WBS and activity coding structure will help determine structure for updating information
- Resource Loaded Construction Schedule
 - Understand how resource hours are distributed per WBS element as well as throughout the project lifecycle

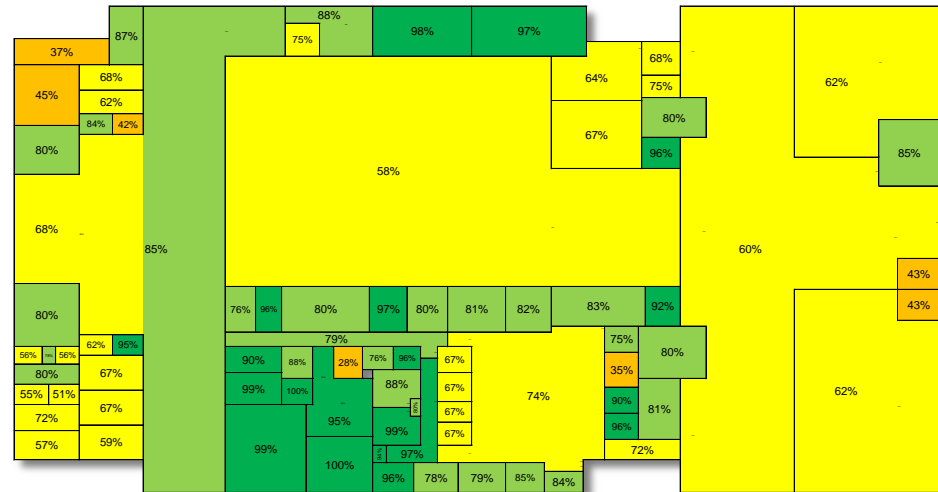
- Another example of the flexibility of the evaluation process used in the case study are the following examples:
 - Percent complete per room via a floor plan view
 - Percent complete for each discipline such as: “Ceiling Grid” per room (notice rooms without ceiling grids are filled in with grey)

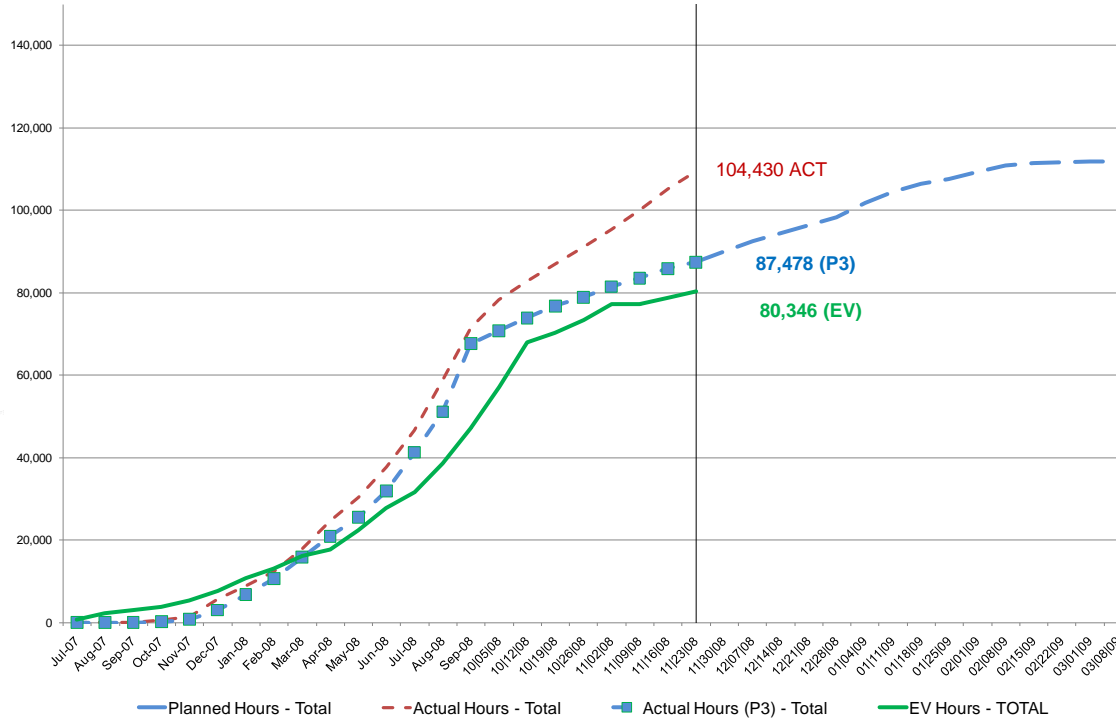
- Data is also used to generate S-curve charts comparing construction schedule to Earned Value (EV)
 - Percent Complete – Construction schedule
 - Percent Complete – Earned Value
 - Variance

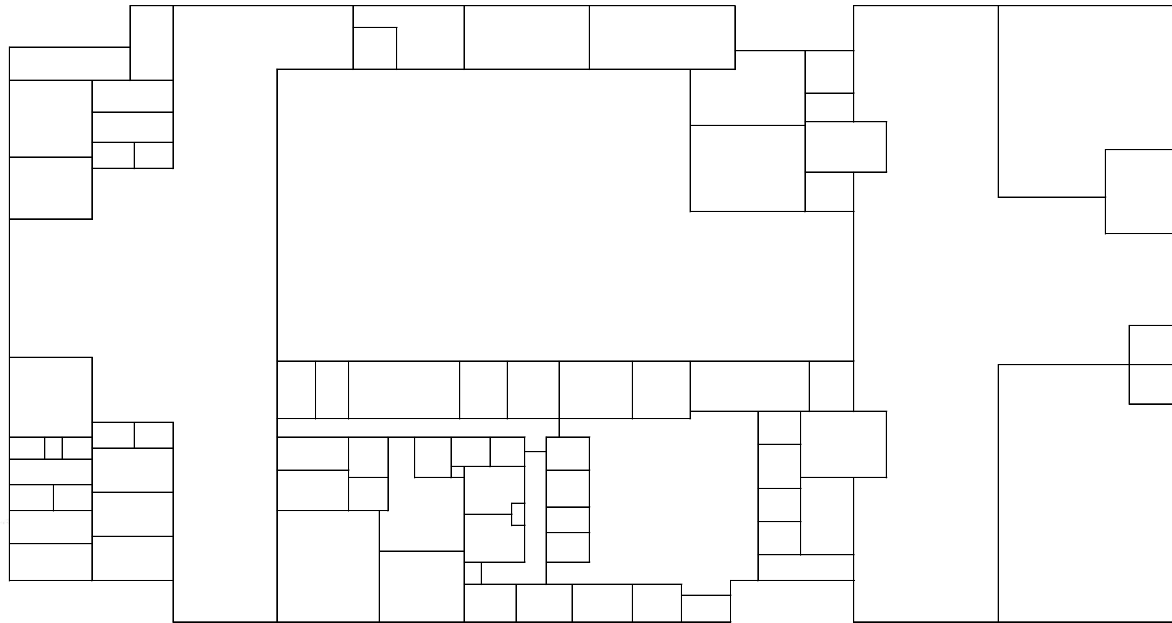
- Project Floor plan

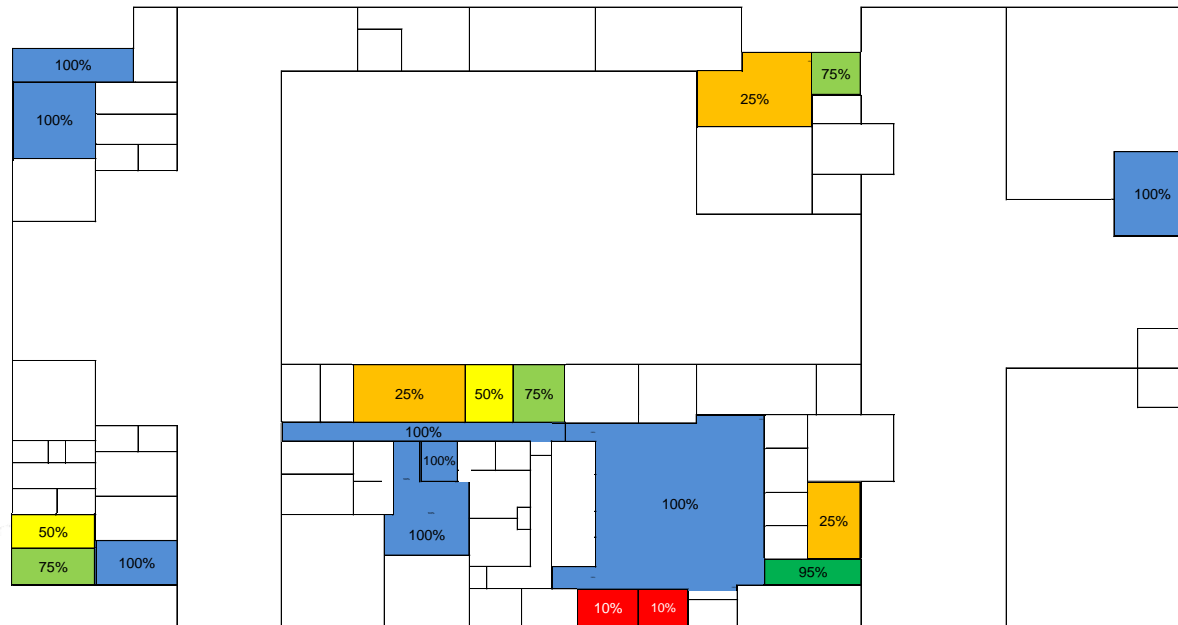
- Conduct a site walk
- Based on tracking of physical components / quantities installed

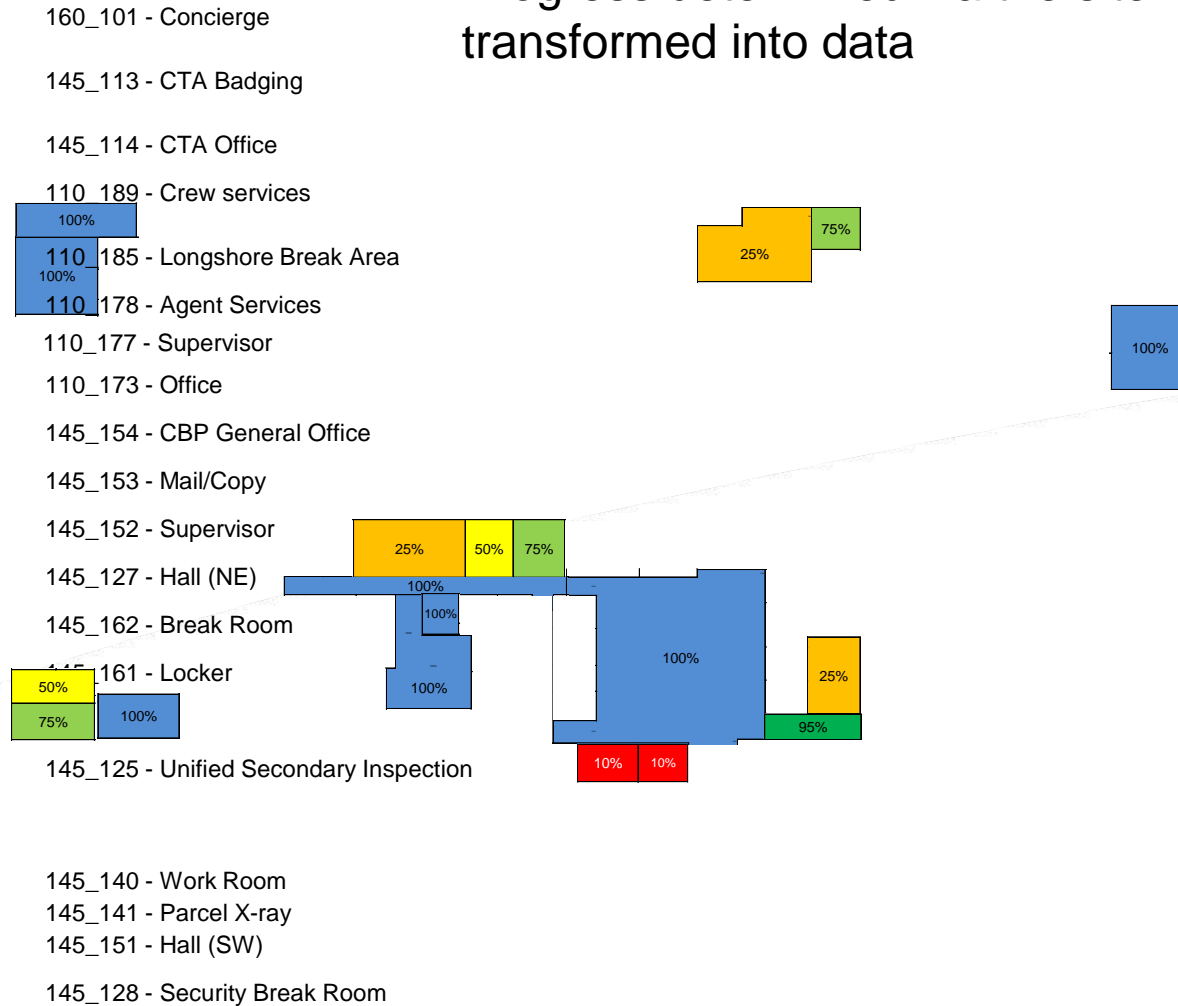
- Progress determined via the site walk is transformed into data

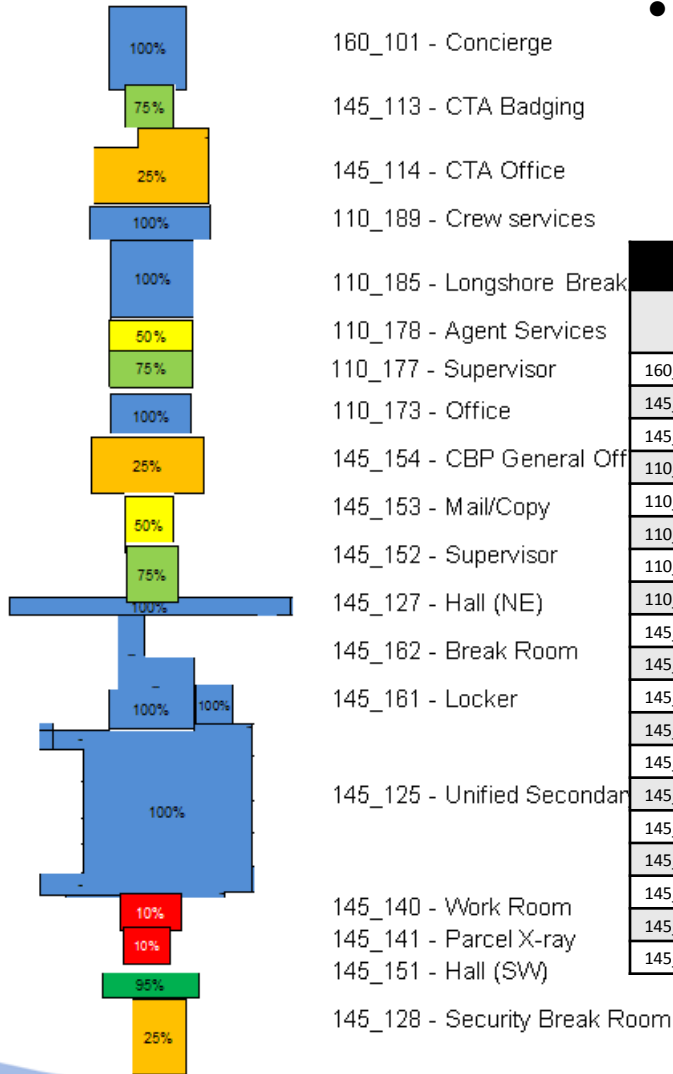
- Progress information is loaded into the database
